BREAKWATER & REVETMENT STABILITY STUDY

SAN JUAN NATIONAL HISTORIC SITE

TECHNICAL REPORT HL-81-11

Hydraulic Model Investigation

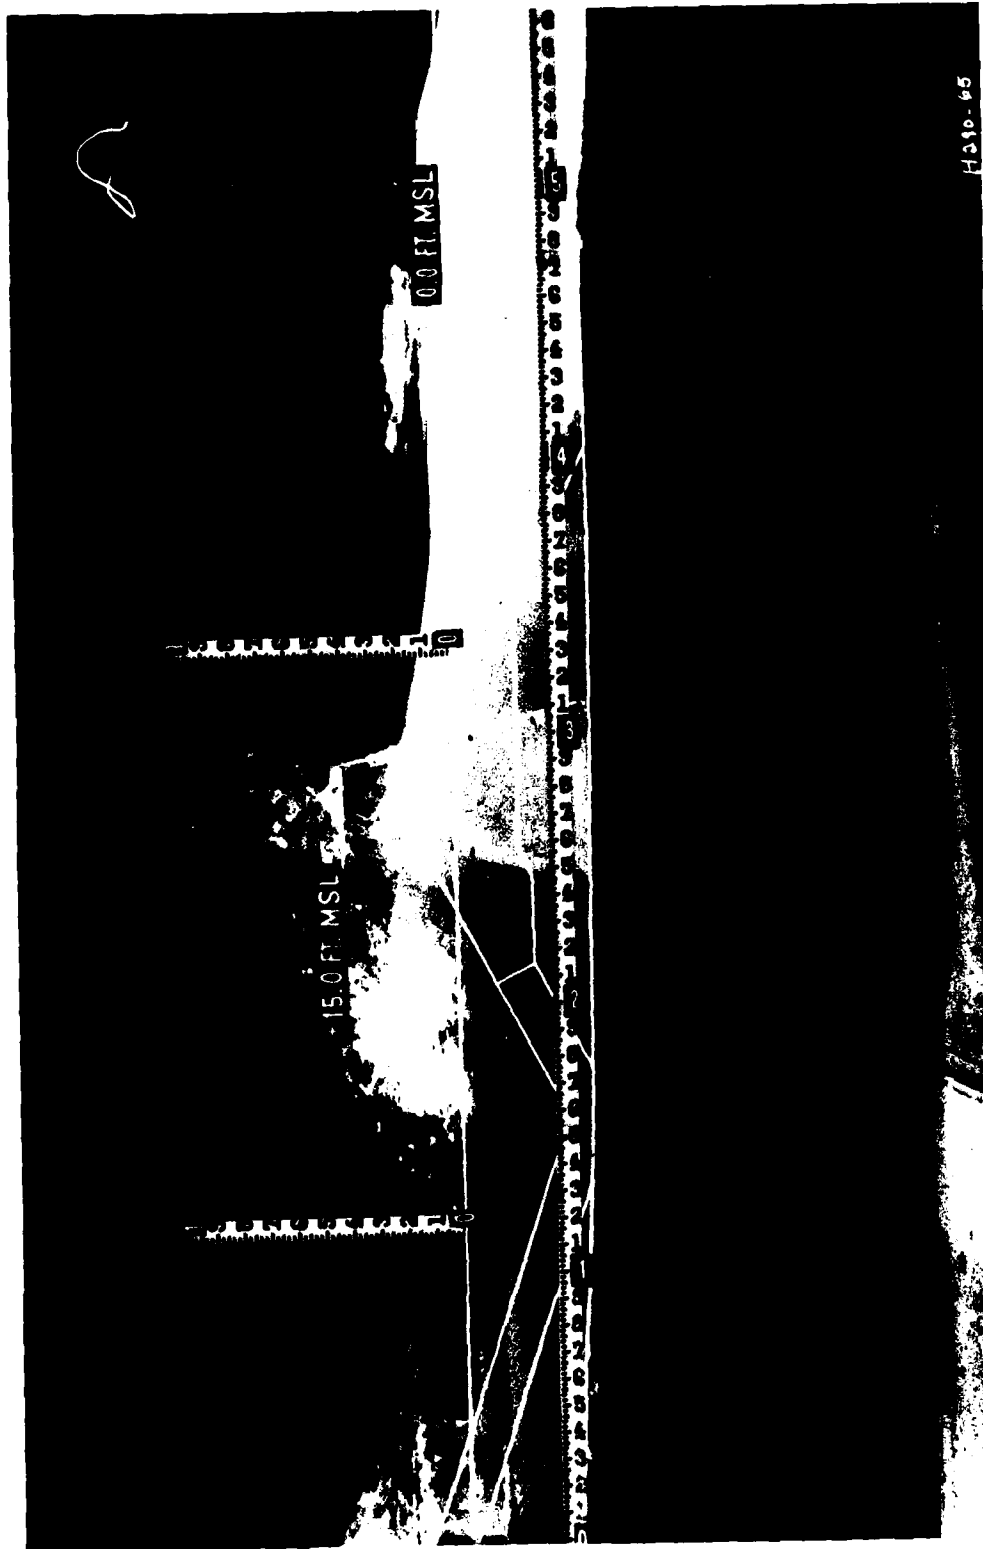
Photo 57. Side view of trestle on north slope, 17.0-sec, 20.0-ft wave at 0.0 swl

Photos 53, 54, 55, and 57 show four of the wave and swl conditions that could be damaging to the trestle.

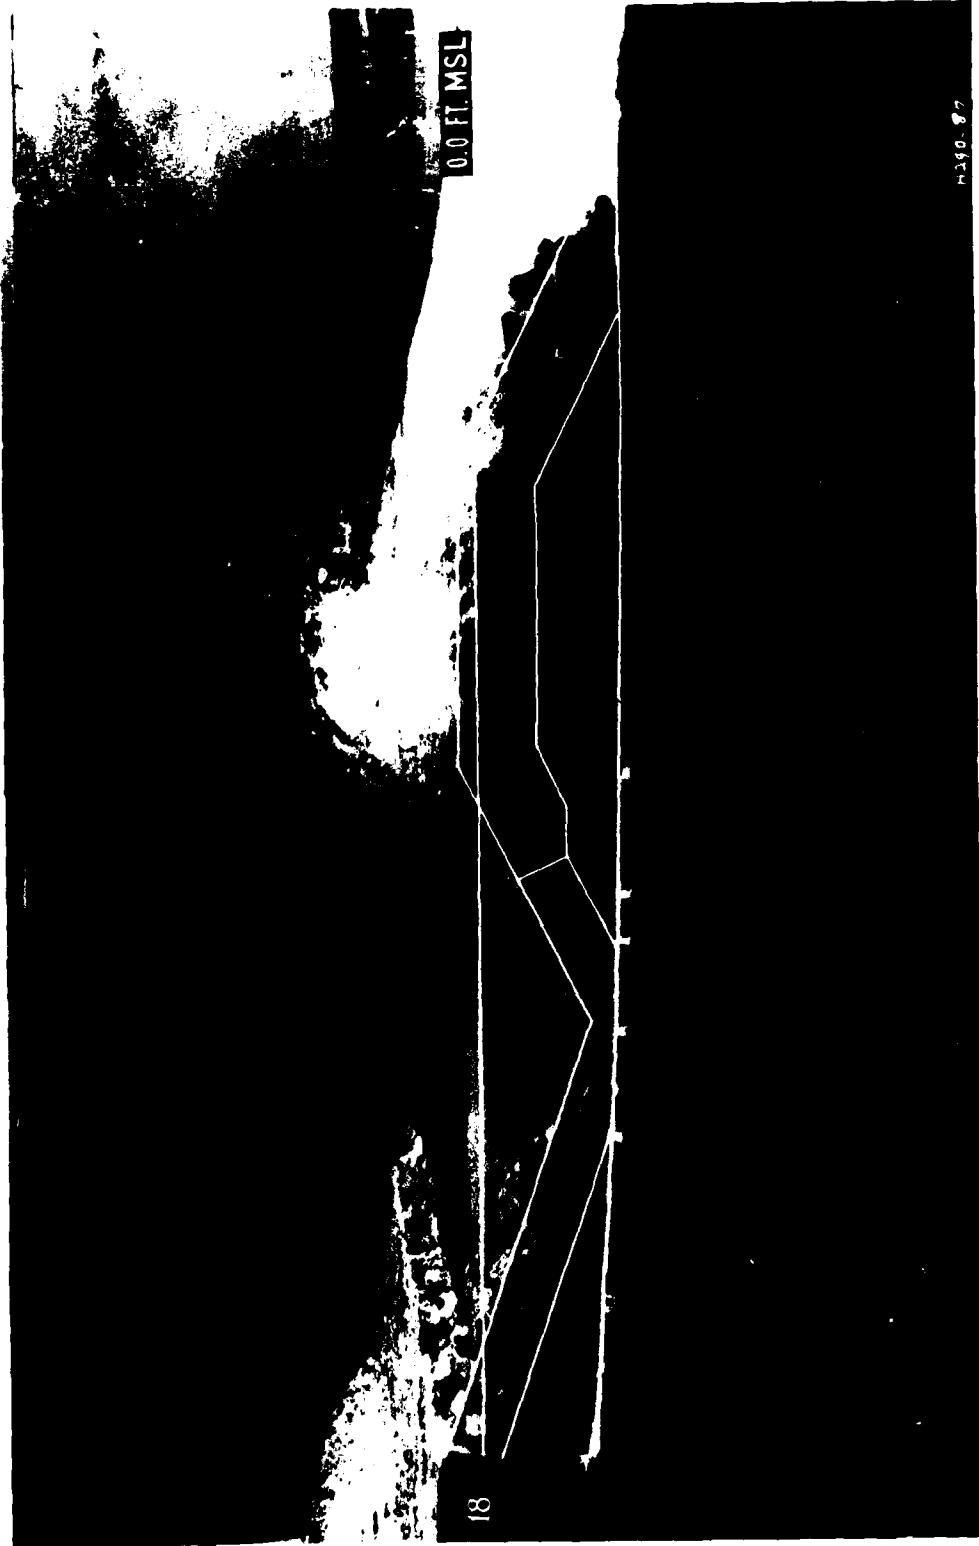
Photo 84. Side view of Plan N-6, 15.0-sec, 20.0-ft breaking wave at 0.0 swl,  
Step 1 of Hydrograph A (Plate 1 and Table 1)

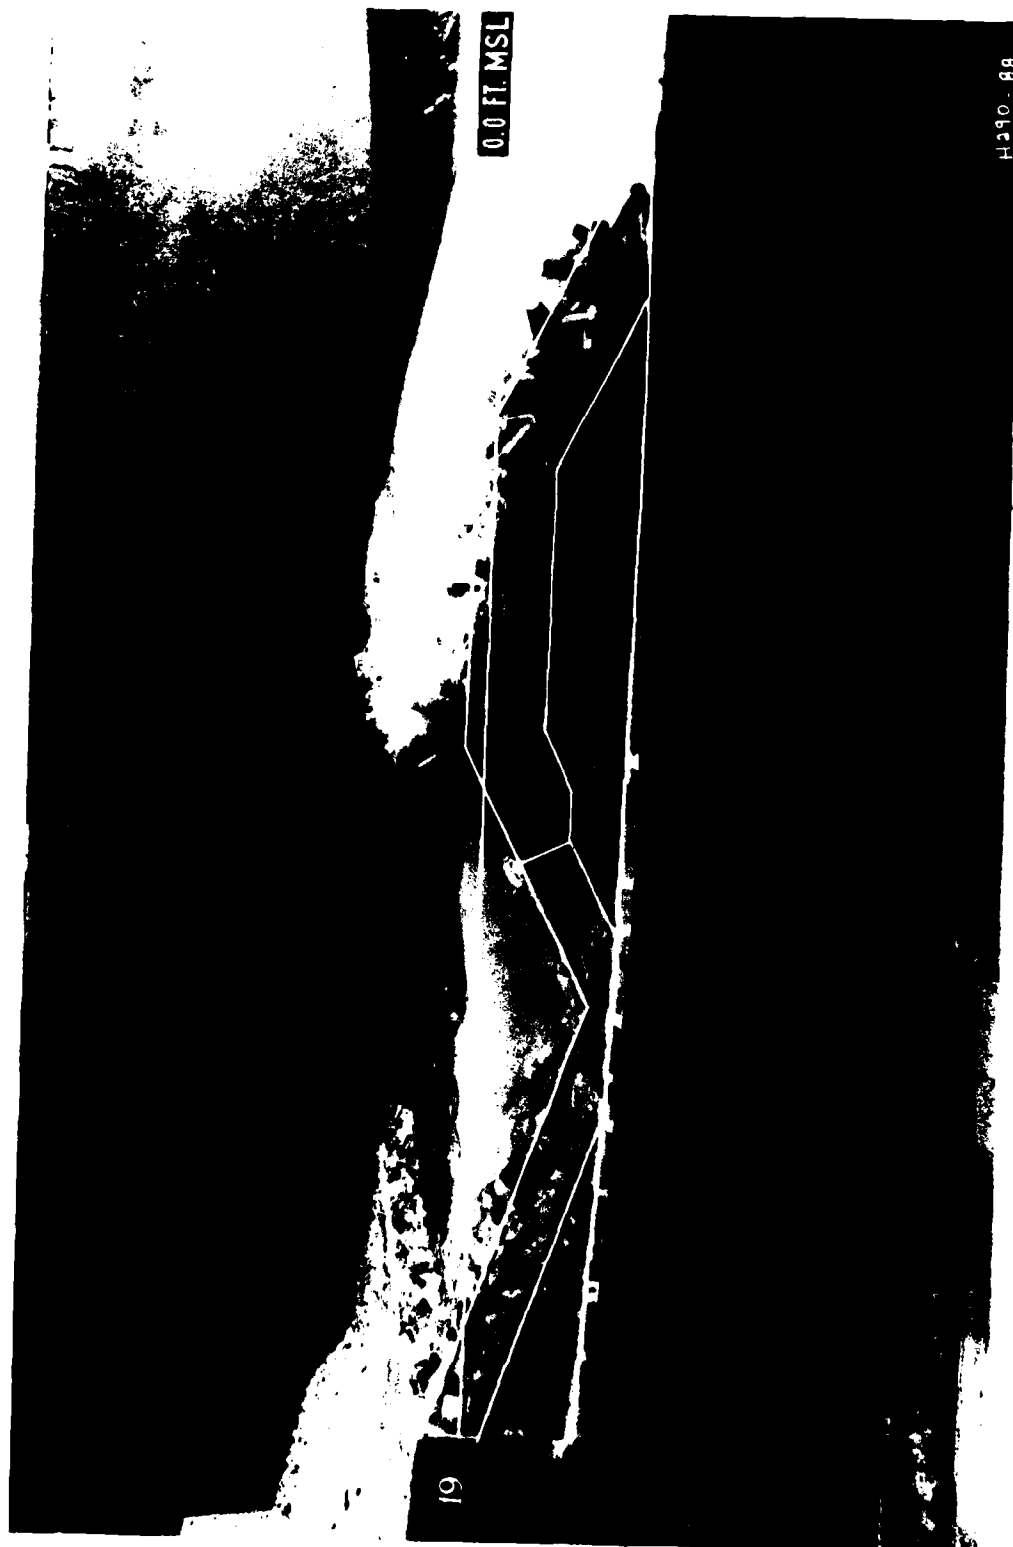
Photo 86. Side view of Plan N-6, 17.0-sec, 22.7-ft breaking wave at 0.0 swl,  
Step 2 of Hydrograph A (Plate 1 and Table 1)

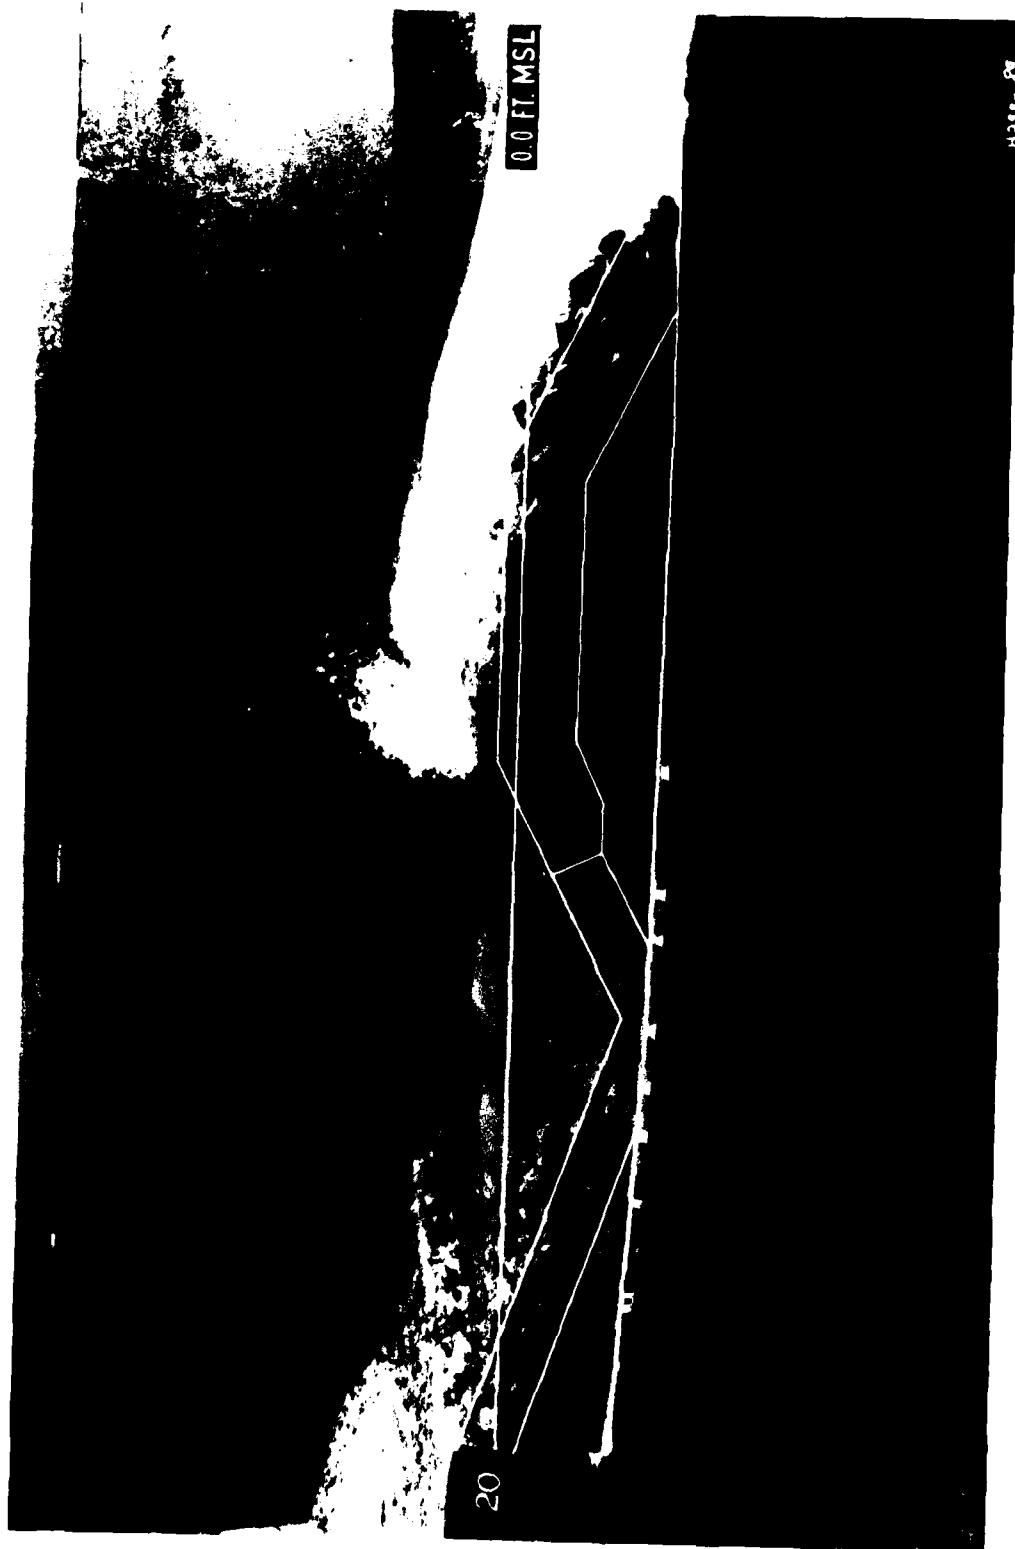
Photo 88. Side view of Plan N-6, 15.0-sec, 21.2-ft breaking wave at +1.9 swl,  
Step 3 of Hydrograph A (Plate 1 and Table 1)

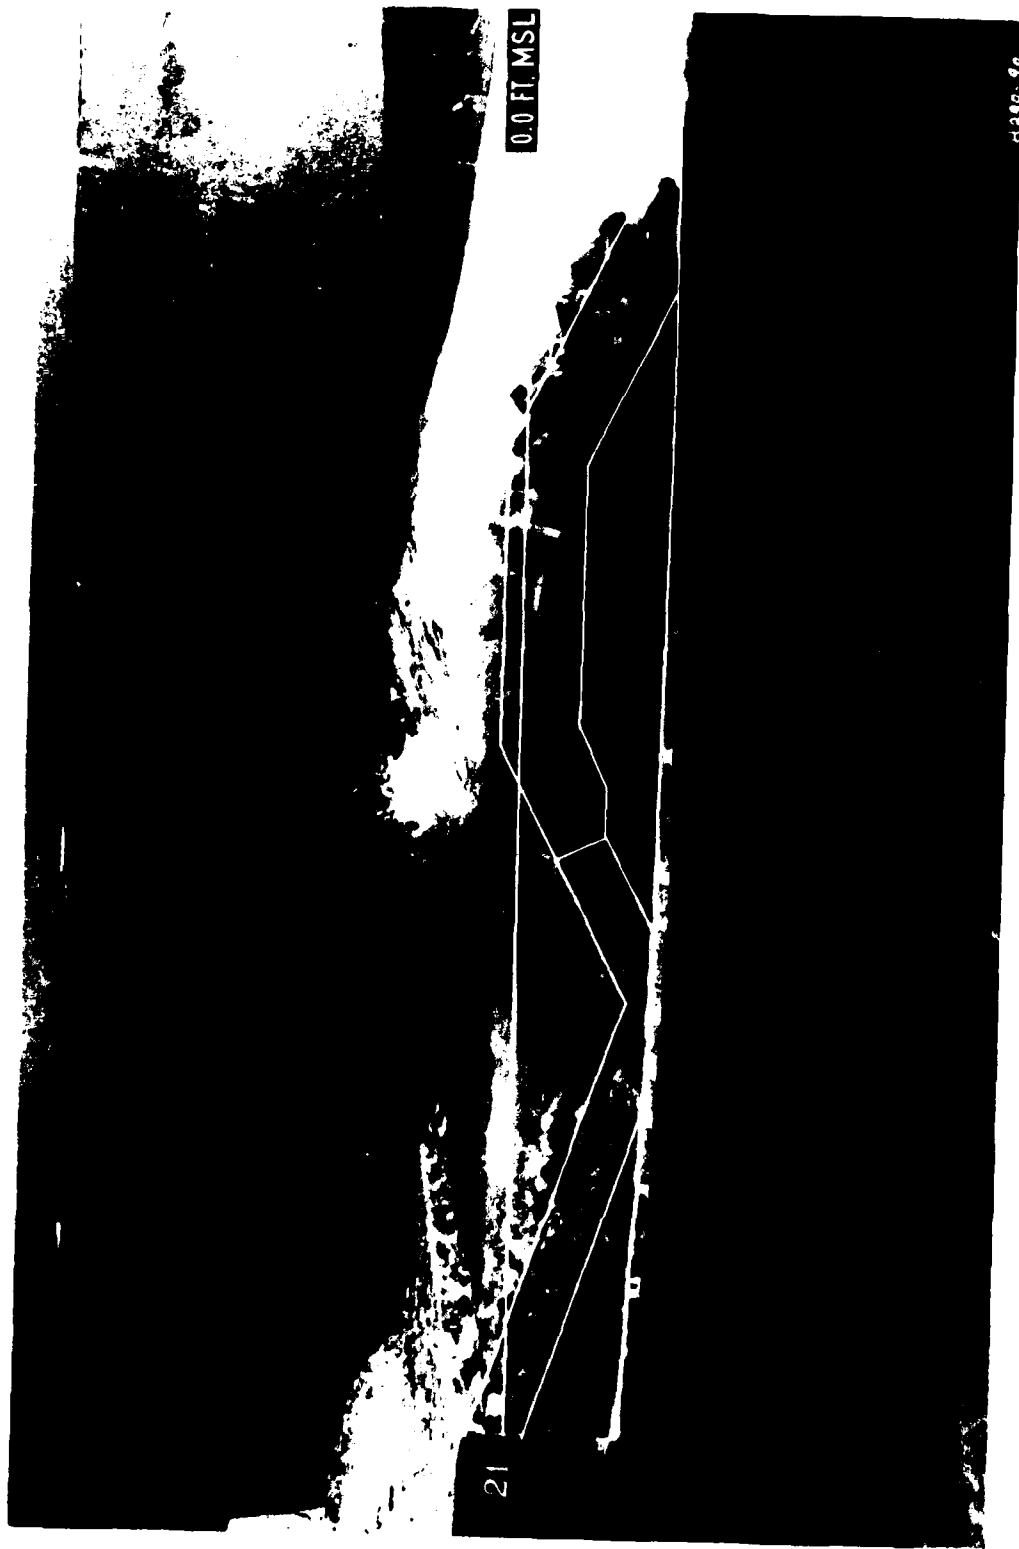
Photo 90. Side view of Plan N-6, 17.0-sec, 23.3-ft breaking wave at +1.9 swl,  
Step 4 of Hydrograph A (Plate 1 and Table 1)

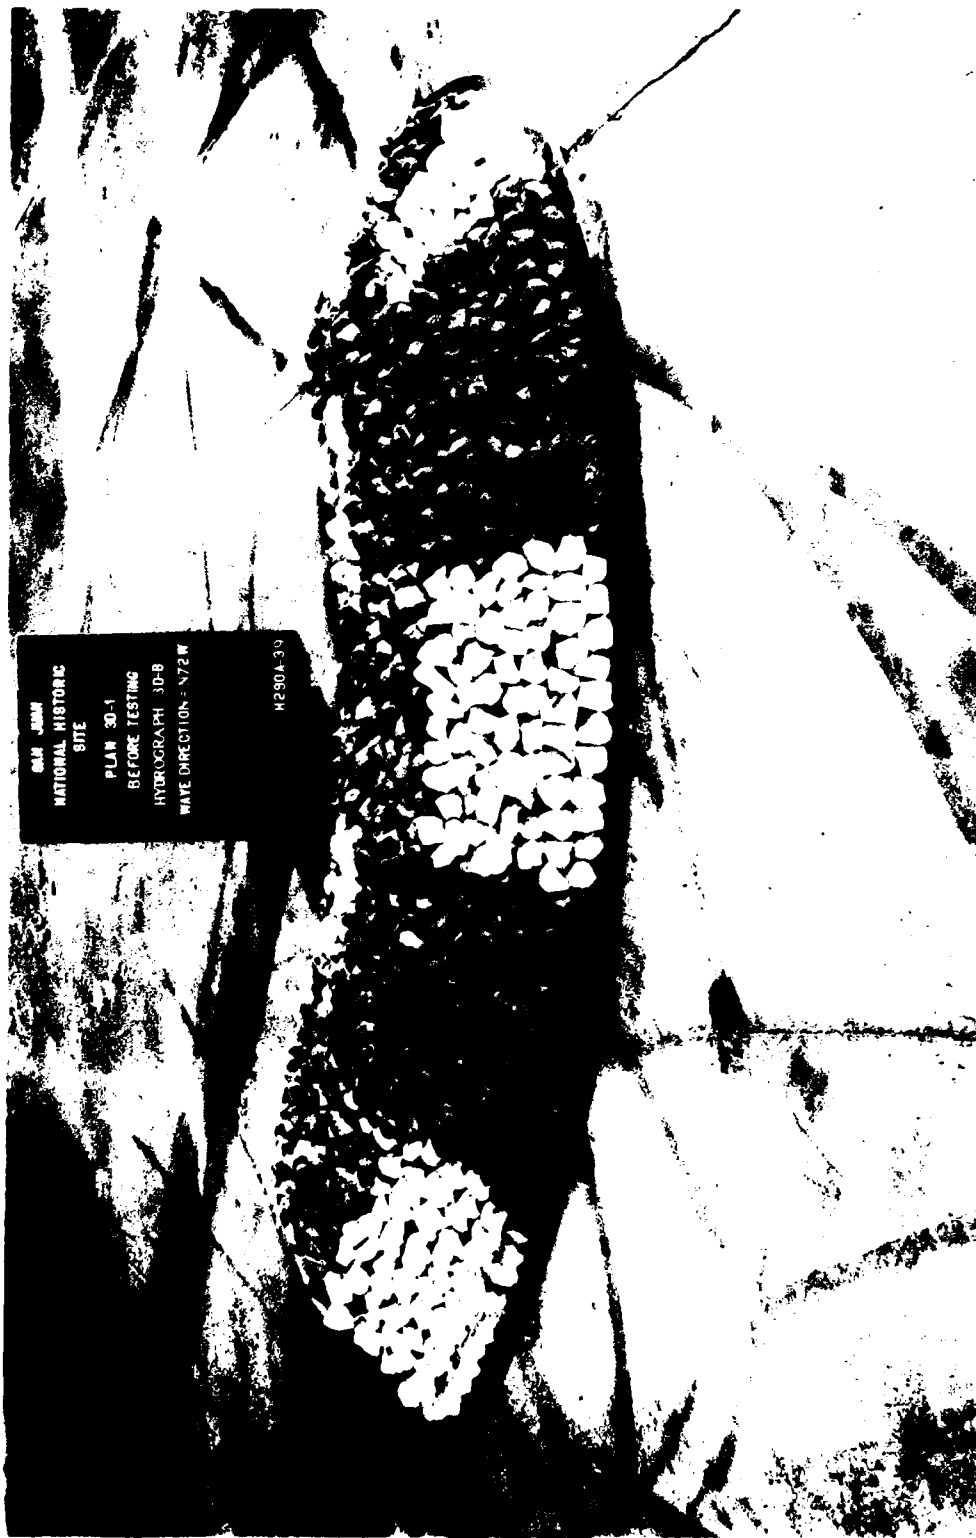
Photo 136. Sea-side view of Plan 3D-1 before testing N72°W wave direction, 1st test section

53. Wave direction N72°W. Plan 3D-1 was reoriented for wave attack from N72°W (Plate 33). After being rebuilt (Photos 136-138) the structure was exposed to the wave and swl conditions of Hydrograph 3D-B (Plate 4 and Table 4). As seen in the after-test Photos 139-141, a

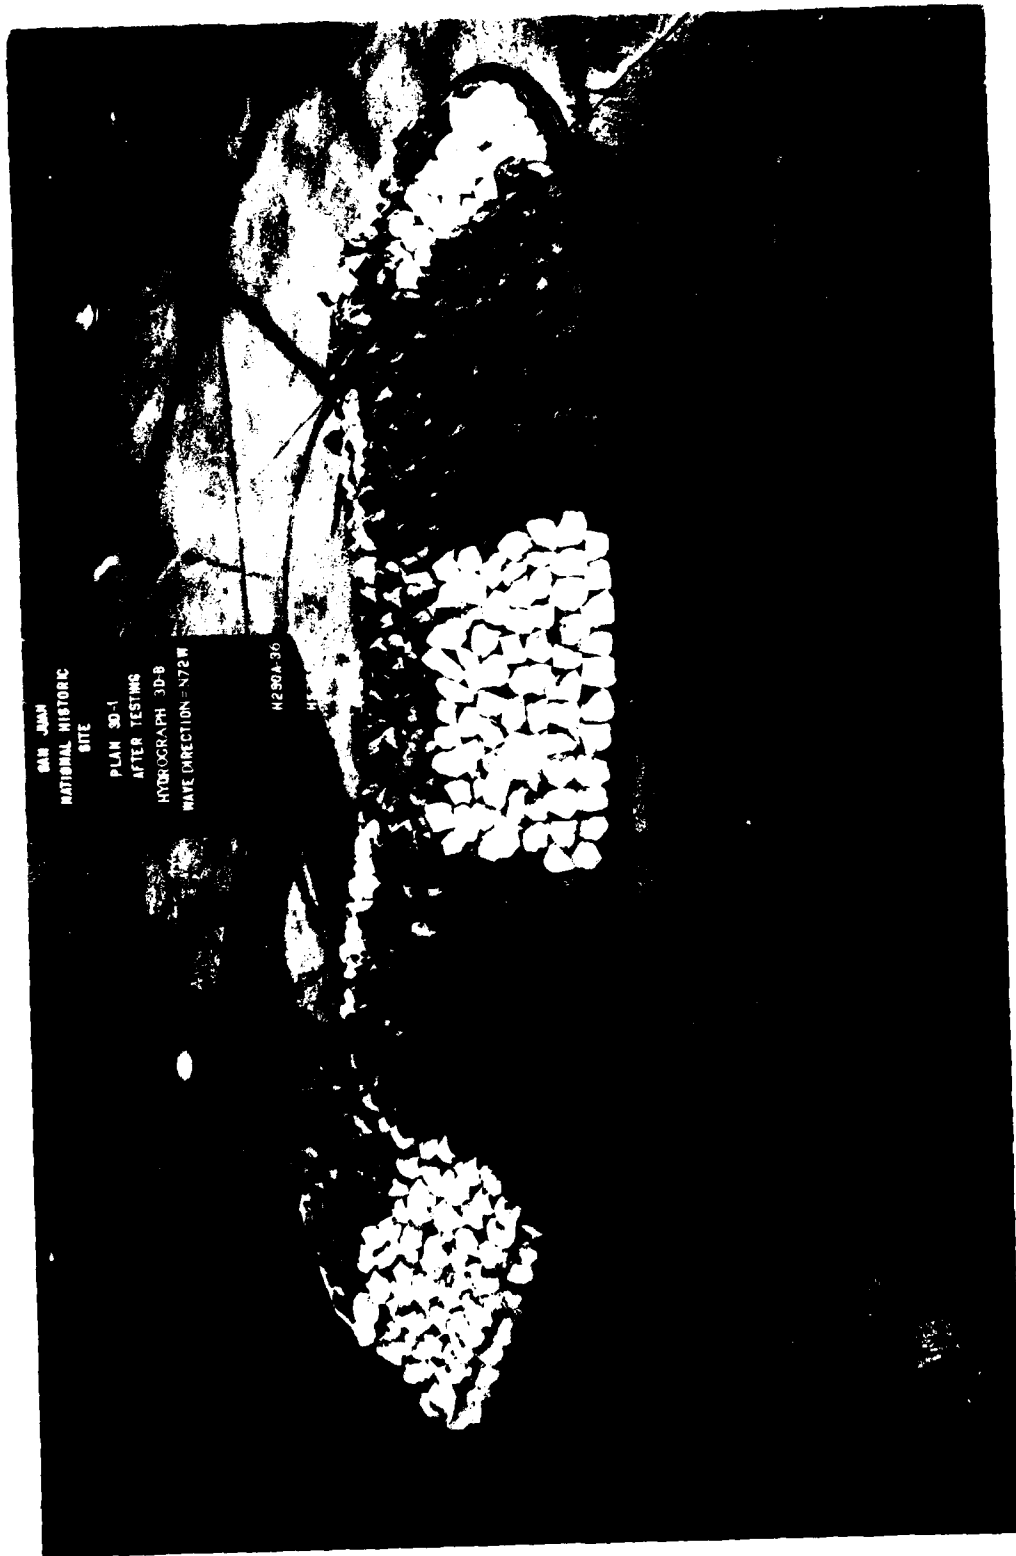
Photo 139. Sea-side view of Plan 3D-1 after testing Hydrograph 3D-B (Plate 4 and Table 4) for N72°W wave direction, 1st test section

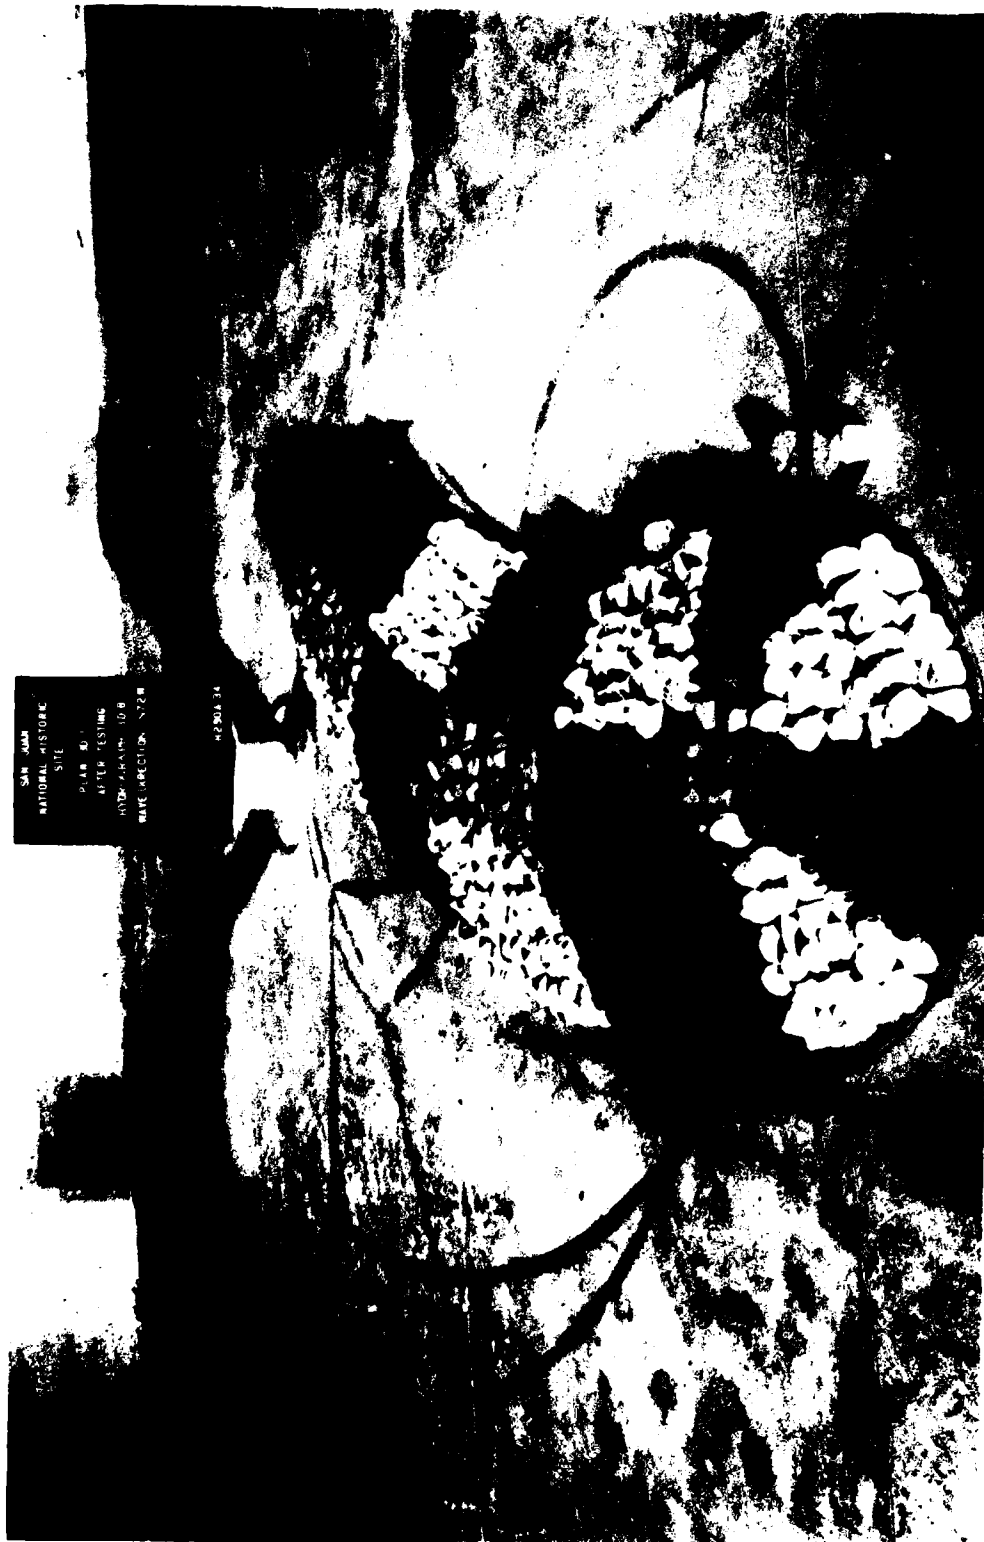
Photo 143. End view of Plan 3D-1 after testing Hydrograph 3D-B (Plate 4 and Table 4) for N72°W wave direction, 2nd test section

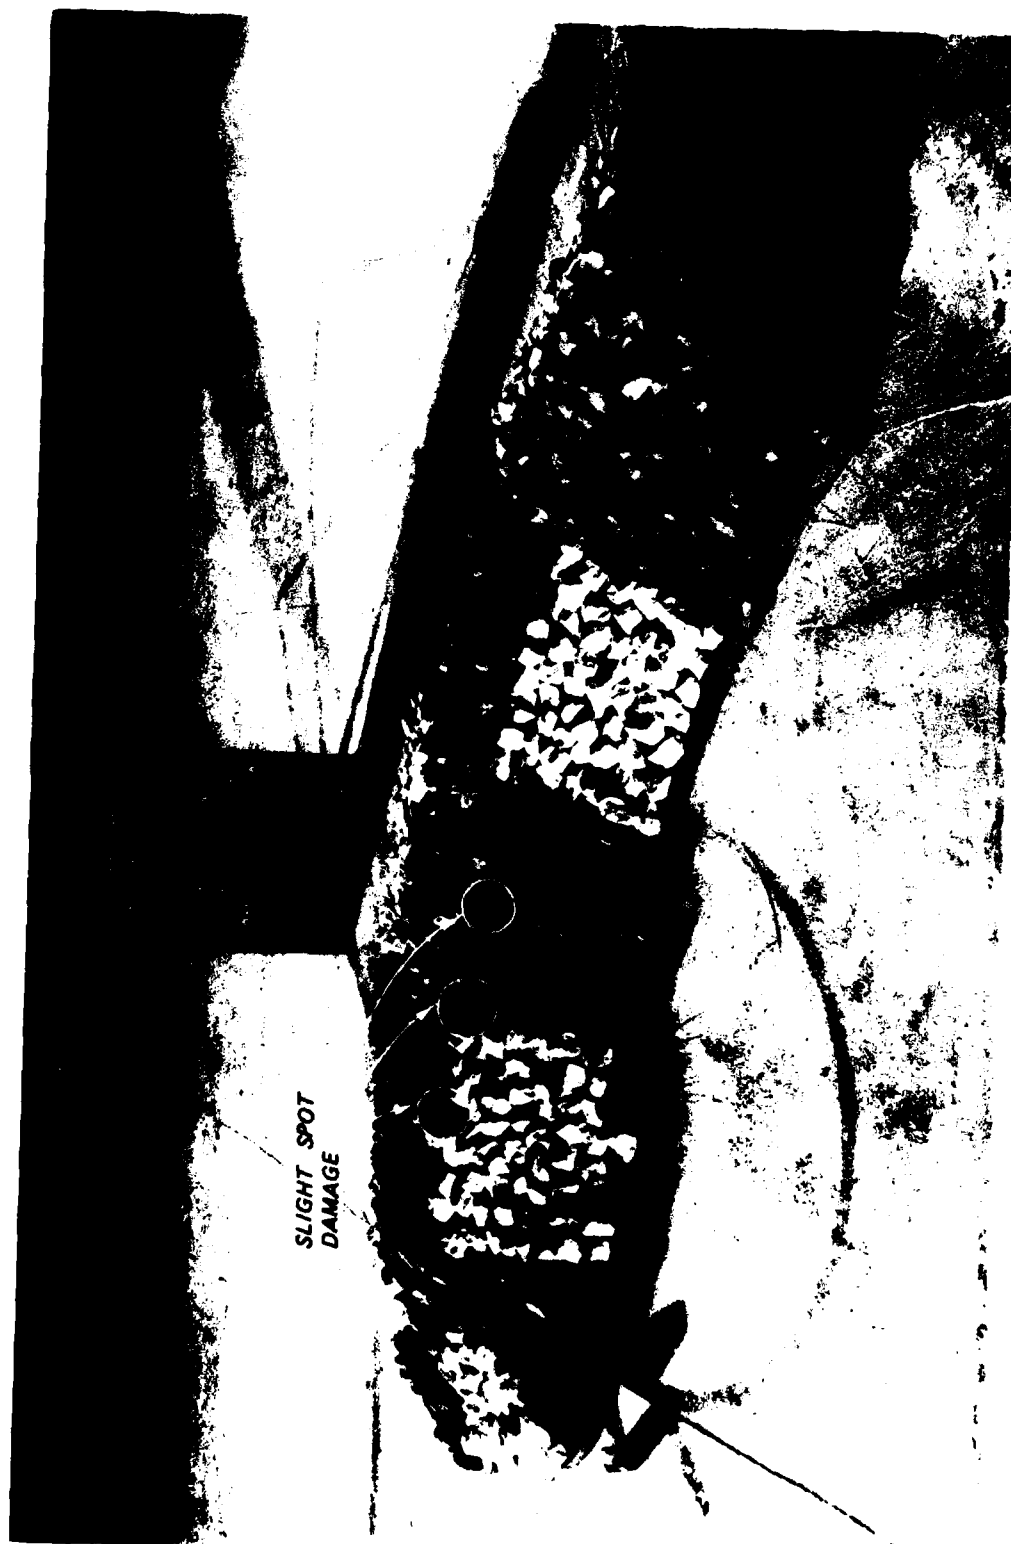
Photo 144. Beach-side view of Plan 3D-1 after testing Hydrograph 3D-B (Plate 4 and Table 4) for N72°W wave direction, 2nd test section
